**Flood Control Project Maintenance  
Levee Inspections**

**Spring 2014 Levee Inspection Results**

**Madera County FCWCA**

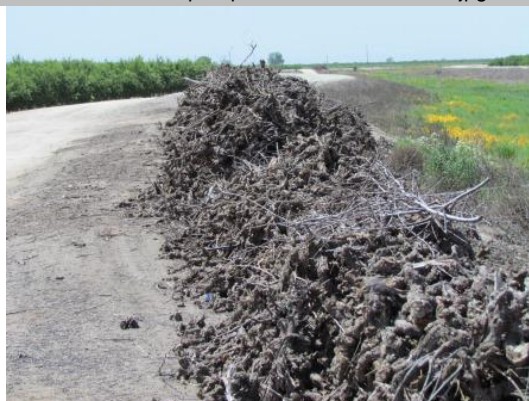
Photo 1 of 1 : phillips\_s\_20140519\_05893.jpg

LM Start	8.94	Rating **	U	Issue No.	43
LM End	8.94	Issue Type +	En	Location *	WS
Category	Earthen Levee			GPS Latitude/Longitude	
				Start	End
Item	Encroachments			36.971983 °	36.971983 °
				-120.215025 °	-120.215025 °
DWR ID	DWR_NA0011_06_s _ 2013_43				
Action/Comments					
Prunings

Levee mile 8.94 looking downstream. Photo 4-24-2014.
